Client Contact:
Mr. Charles Krogh
Pinery Water and
Sanitation District
303-841-2797

Project Summary:

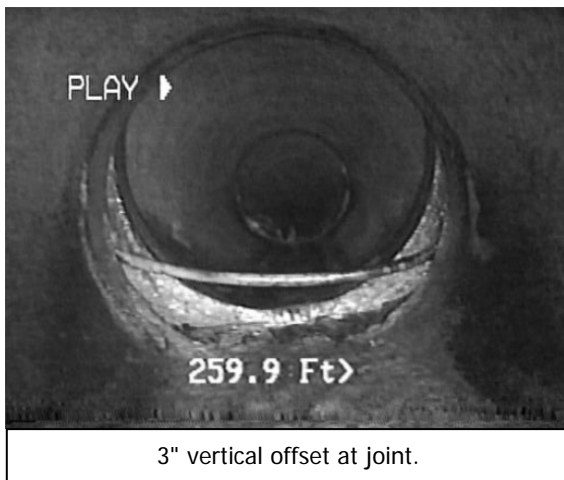
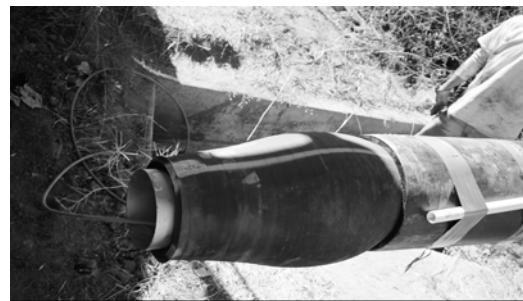
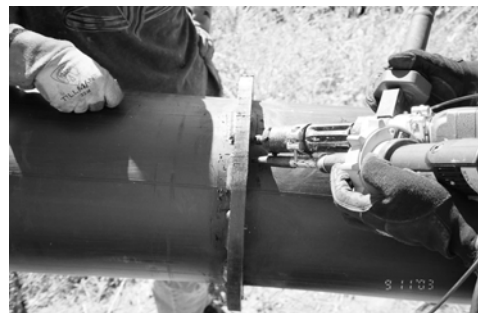
Cesare, Inc. (Cesare) recommended a repair for the leakage flows at The Pinery Dam which were coming out of the existing outlet conduit and were continuous and measured over 60 gallons per minute (gpm) with small amounts of embankment material. An attempt was made using an inflated flexible tube type lining set in place with epoxy resin from the downstream end. The Pinery Dam (a.k.a. Bingham Lake Dam), located near Parker, Colorado, is a zoned embankment dam over 50 feet high, constructed in the early 1970's. The Class 2 dam has a 350 foot long, 18-inch diameter reinforced concrete pipe (RCP) outlet conduit with a reinforced concrete cradle. A remote controlled video camera was used to locate the source found to be a 3-inch vertical offset at a pipe joint about 260 feet from the downstream end of the outlet conduit. Draining the reservoir was to be avoided, so a repair solution had to be performed either underwater on the upstream side or entirely from the downstream end. The leakage flow in the pipe and associated pressures, caused the flexible tube lining to be forced back out of the outlet conduit. Cesare recommended repair using a high density polyethylene pipe (HDPE) slip lining with annular grouting, after evaluating several alternatives. Although the HDPE slip lining was the least expensive alternative, the leakage flows and the distance to the vertical offset joint presented a risk with this approach. The slip lining solution required an inflatable Packer, remote controlled video camera, and 12 1-inch diameter grout lines up to 300 feet long. Twelve grout cells filled with non-shrink grout were constructed in the annular space between the HDPE and the RCP along the slip lining length. After the successful installation, the measured leakage flow was reduced to about 4.8 gpm.
