**Mr. Charles Krogh  
Pinery Water and  
Sanitation District  
303-841-2797**

**Project Summary:**

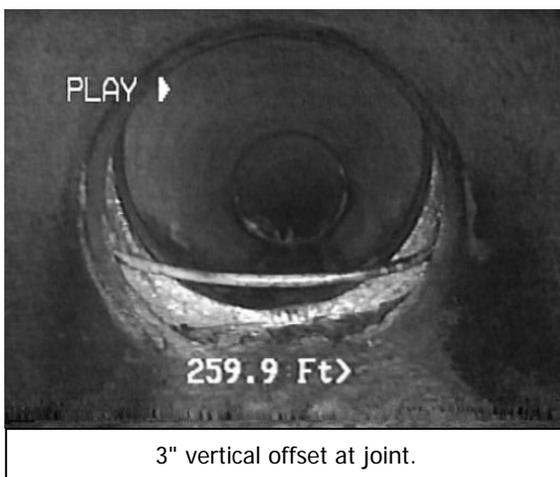
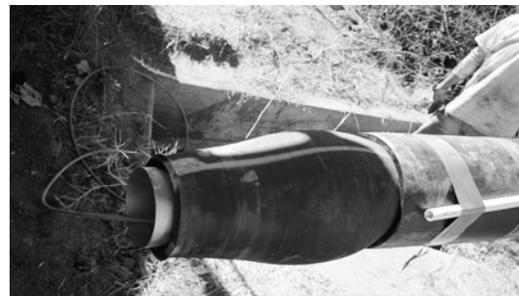
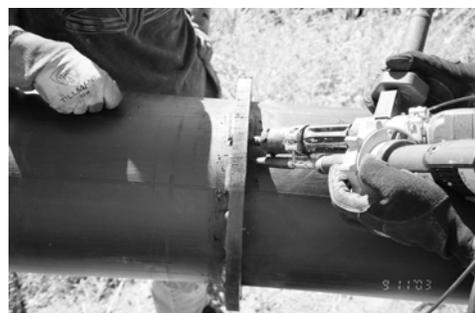
Cesare, Inc. (Cesare) recommended a repair for the leakage flows at The Pinery Dam which were coming out of the existing outlet conduit and were continuous and measured over 60 gallons per minute (gpm) with small amounts of embankment material. An attempt was made using an inflated flexible tube type lining set in place with epoxy resin from the downstream end. The Pinery Dam (a.k.a. Bingham Lake Dam), located near Parker, Colorado, is a zoned embankment dam over 50 feet high, constructed in the early 1970's. The Class 2 dam has a 350 foot long, 18-inch diameter reinforced concrete pipe (RCP) outlet conduit with a reinforced concrete cradle. A remote controlled video camera was used to locate the source found to be a 3-inch vertical offset at a pipe joint about 260 feet from the downstream end of the outlet conduit. Draining the reservoir was to be avoided, so a repair solution had to be performed either underwater on the upstream side or entirely from the downstream end. The leakage flow in the pipe and associated pressures, caused the flexible tube lining to be forced back out of the outlet conduit. Cesare recommended repair using a high density polyethylene pipe (HDPE) slip lining with annular grouting, after evaluating several alternatives. Although the HDPE slip lining was the least expensive alternative, the leakage flows and the distance to the vertical offset joint presented a risk with this approach. The slip lining solution required an inflatable Packer, remote controlled video camera, and 12 1-inch diameter grout lines up to 300 feet long. Twelve grout cells filled with non-shrink grout were constructed in the annular space between the HDPE and the RCP along the slip lining length. After the successful installation, the measured leakage flow was reduced to about 4.8 gpm.
